INVESTIGATIONS TO ASSESS INDUSTRIAL DUMPS AT UCIL, BHOPAL

UCIL (Union Carbide India Ltd.) had been producing pesticides and insecticides since the inception of its factory in 1969 in Bhopal (M.P.) India. After the MIC gas leakage in December 1984, the production had stopped and subsequently the factory has been closed. Some of the structures are lying in the premises, many buildings are demolished. The industrial wastes are dumped at different places. In order to assess the locations and dimensions of these dumps, geophysical investigations have been carried out. Geophysical investigations are used to identify buried industrial waste that cannot be easily identified by visual inspection. It is most economical and successful technique to assess the buried dump before a more detailed investigations or remedial measures can be adopted. The investigations have been financed by MP State Govt. namely BGRD (Bhopal Gas Relief Directorate) and Ministry of Chemical and Fertilizer (Govt. of India).

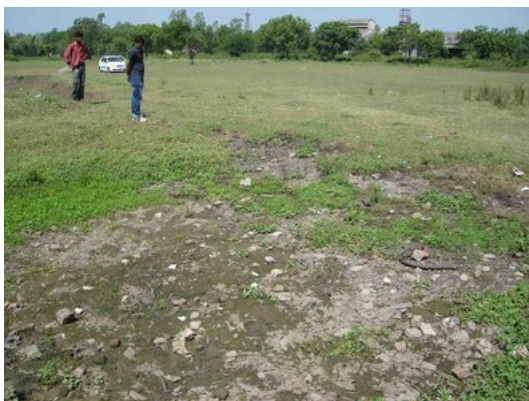
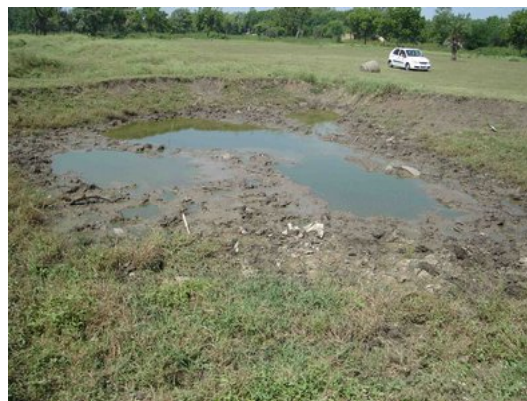
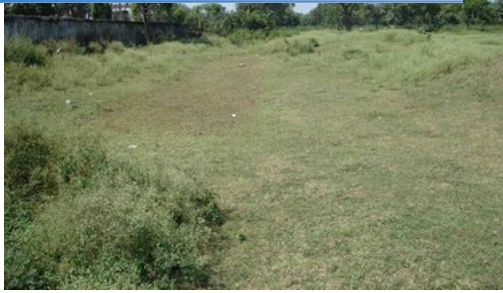
Fig. 3e: Dumps in pit at southern part

Fig. 3f: Dump pit filled with water

Fig. 3g: Dump pit in southern part

Site III: There are pits where burned materials and waste materials are reported (NEERI, 1999) to be dumped as shown in Fig. 3 e, f and g at this site which covers a vast open land (Fig. 11). Due to water logged in these pits and uneven topography we were

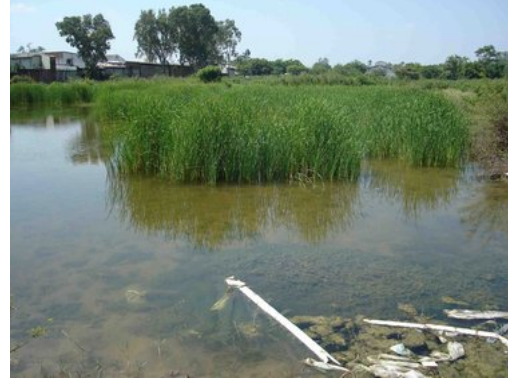
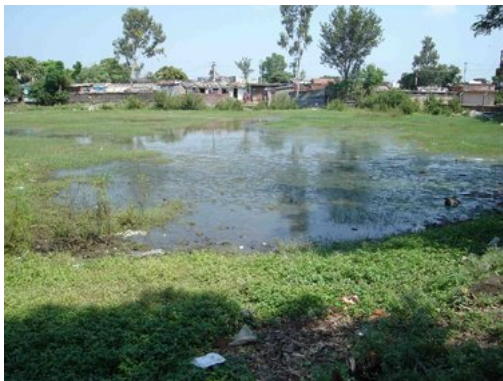
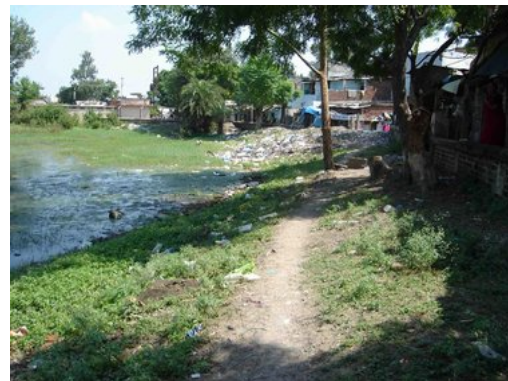
Fig. 3h: SEP-II filled with water

Fig. 3i: SEP-I filled with water

Fig. 3j: SEP-I attracting domestic waste

area east of Police Post and the open space between Neutralization tank and SEP (Fig. 11). The SEP I and II are water logged as shown in Fig. 3 h, I and j, hence could not be covered. The SEP-I is also made a dump site for domestic waste from nearby settlements. The heaps of dump are seen along the road leading to SEP. A strong smell of pesticides makes it difficult to work in the area. The first profile is selected along the road in EW direction across the dump as shown in Fig. 11. The electrode separation was kept as 1m so that maximum space available of 48m will be covered. The 1st electrode was kept in west near Police post. The data was obtained and processed for any error and interpreted using RES2DINV software. The final profile obtained after several iteration is shown in Fig. 23. It can be observed that the dumps are clearly depicted in the profile. The dump is shallow (0.7m) between 8 to 10m along the profile and deep (1.3m) between 10 to 16m along the profile. Again the dump becomes shallow all along the profile.

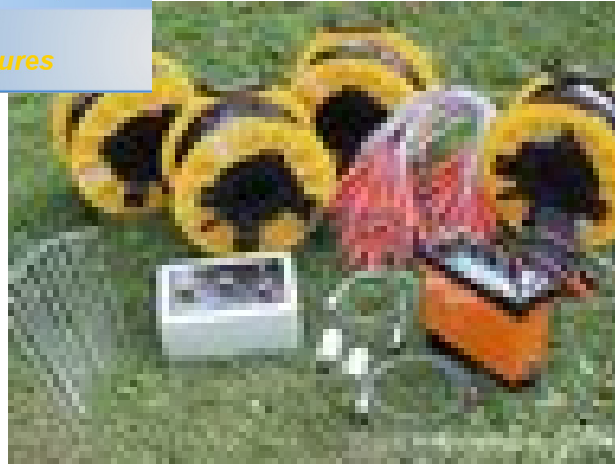
Fig 6 ABEM Terrameter with accessories (source: www.abem.se)

The present study has taken advantage of latest technology of resistivity imaging and its application for detecting dump with the use of multi-electrode geo-electrical investigation. The High Resolution Electrical Resistivity Tomography (HERT) has been carried out to obtain 2D (two dimensional i.e. vertical profile) as well as 3D (three dimensional i.e. horizontal profile at different depth) distribution of resistivity of subsurface strata. An equipment SAS4000 (Fig. 6) from ABEM, Sweden has been used. The data were interpreted using RES2DINV (2005) software. Equipment SAS4000 consists of Terrameter, Junction box, multi core cables and electrodes as shown in Fig. 6. The four channel system allows selecting the array and then data is recorded on the terrameter. The data is then transferred to PC and software RES2DINV is used to process the data. Initially, data is converted to proper format then edited for any error. The 2D data is then inverted to layered resistivity model. The gradient array system was adopted to obtain data.

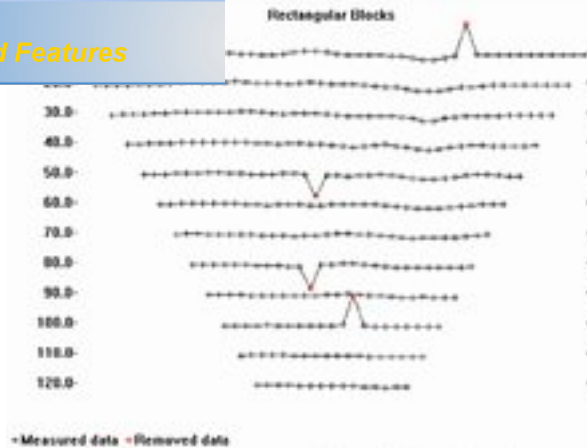
Fig. 8: Example of data set with few bad points (source: RES2DINV Manual)

The entire downloaded data were first checked for errors. Any error in the measured data was removed while processing through RES2DINV. An example of bad data record is shown in Fig. 8 . Such bad data records are removed before interpreting the profile.

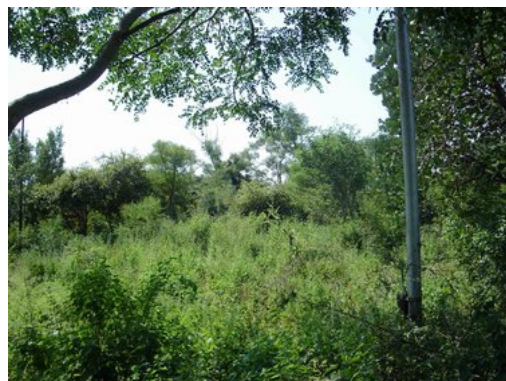
Fig. 10 DenseBushes in UCIL premises

As it can be seen that most of the area is covered with construction, roads etc., and the soil covered area is the only place where we can perform HERT. Again many part of the open land area is covered with bushes (Fig.10) and it is difficult to penetrate these thorny bushes. There are ponds such as SEP in the southeastern part, pits filled with water and surrounded with bunds (in southern and eastern part) of premises. Such places cannot be scanned with geophysical method. A reconnaitory survey has been carried out to locate suitable places for HERT and effort has been to cover as much area as possible. The location of these profiles is shown in Fig.11.
